**2014 PSRU MODS, Nov 29, 2014 follow up, RV-9A N678RA
Egg 2.5L SOHC Subaru, MT Prop**

This document is a follow up to “2014 PSRU MODS, RV-9A N678RA” dated Sept 11, 2015.

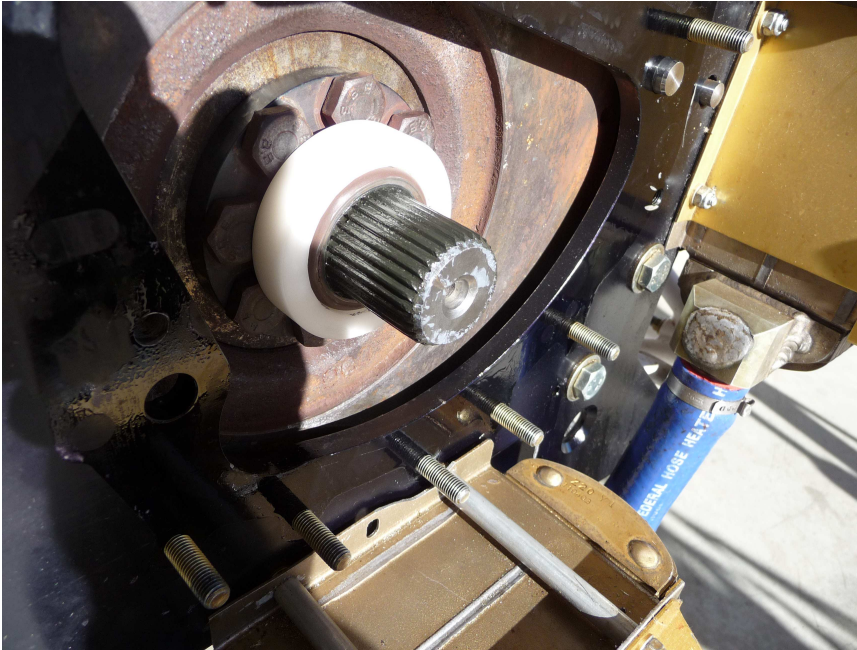
Upon disassembly of the gearbox from the engine mount plate I found that the added seal has functioned as intended. No Moly 60 has been lost. Note that the O-ring only has Moly 60 on it inside of the sealed area.

The first photo shows the spline shaft with gearbox removed from the airplane. Still completely coated with Moly 60. Note the complete absence of Moly 60 on the black mounting plate. This is a big change.

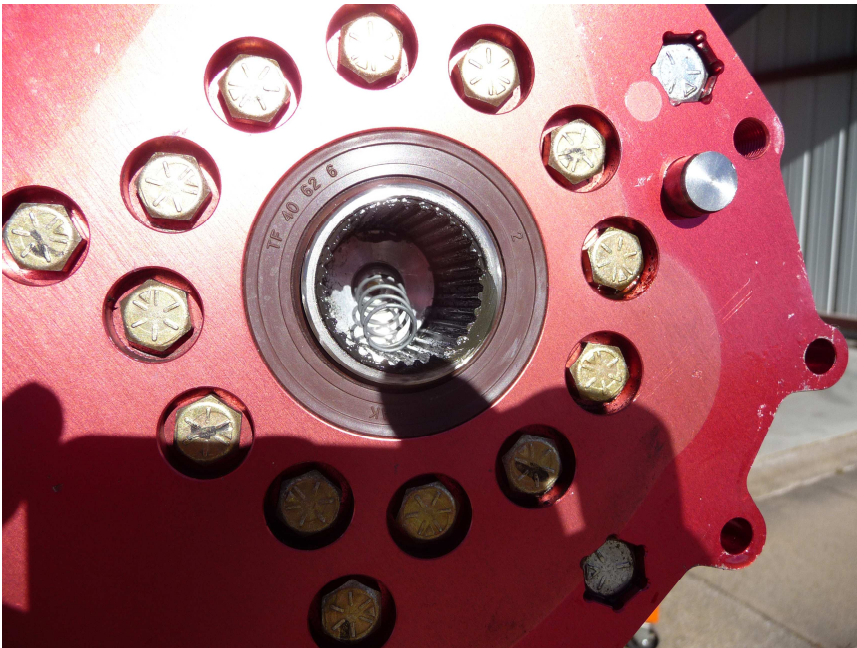
Here is the gearbox as removed. Also completely coated with Moly 60.

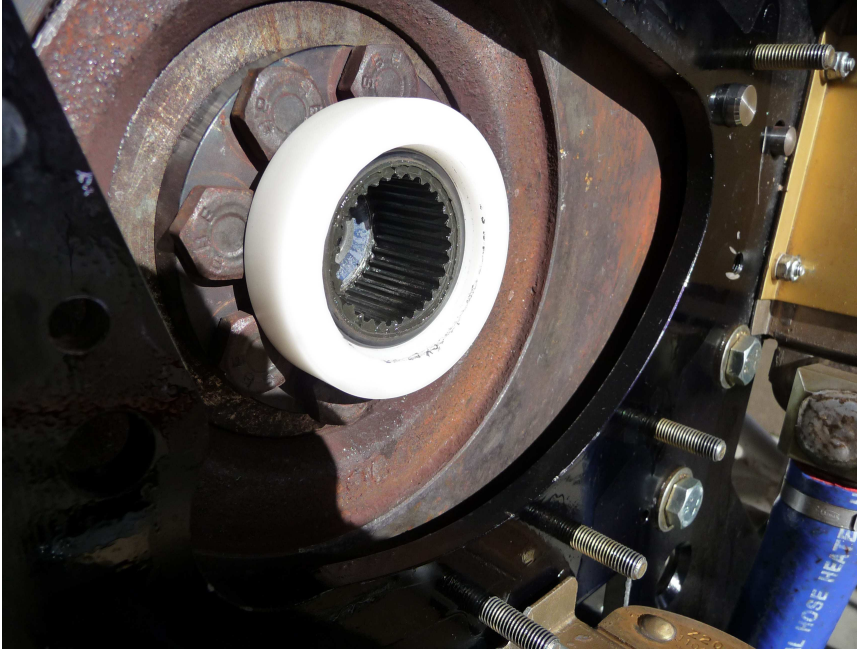
And the flywheel adapter with the spline removed. The spline area is fully coated with Moly 60. Note the dry area where the O-ring sealed against the end of the flywheel adapter.

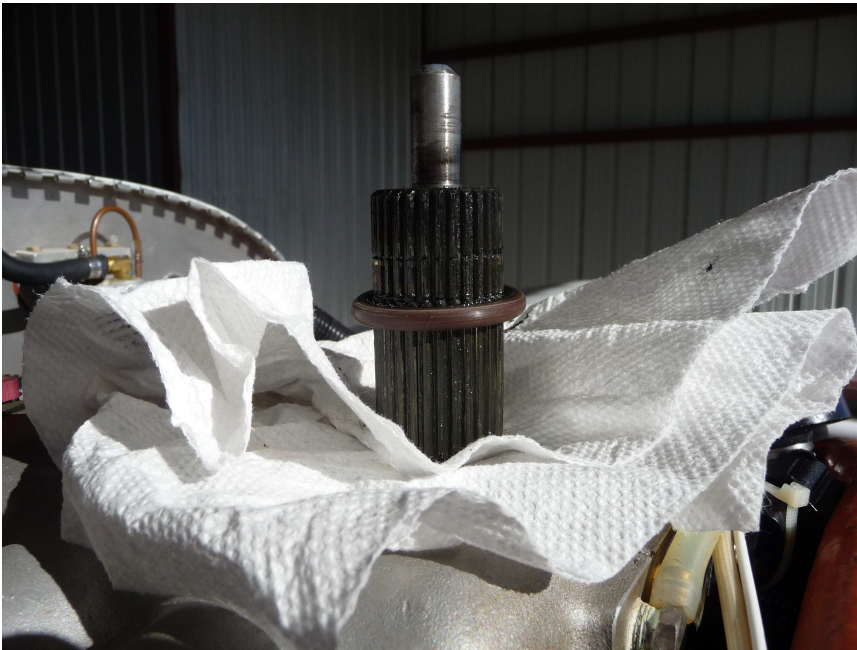
And the spline shaft itself as removed. Still fully coated with Moly 60.

The dimensions seen seem to indicate little to no wear at either end of the spline shaft with some wear occurring at the mid shaft location. This may be due to the repositioning of the spline shaft by the spacer and spring added along with the removal of the snap ring or it may be measurement tolerance. Next planned inspection will be at the next annual condition inspection or 50 hours of operation, whichever comes first.

The spline shaft cleaned up with only lacquer thinner and a paper towel compared to using a dremel tool with a wire brush prior to the seal mod. Hondy Moly 60 was reapplied and the airplane reassembled and test flown with no change in operation noted.
