Introduction

This document is an attempt to share the changes that have been made to the PSRU (Propeller Speed Reduction Unit) installed in Experimental Amateur Built airplane N678RA. I in no way claim this is the best way to accomplish the goal of increased PSRU spline coupling life or even a good way. Only the way I chose to move forward with this learning process.

The Issue

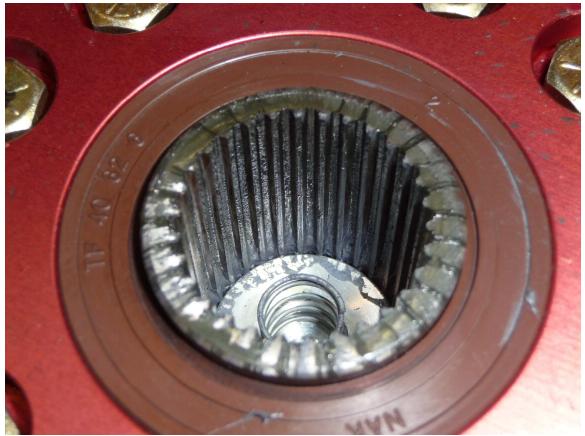
Photo 1

When I removed the PSRU to inspect the spline I found radial streaks of gray on the end of the PSRU input shaft (Photo 1), but the female spline seemed to still be well lubed with Moly 60.

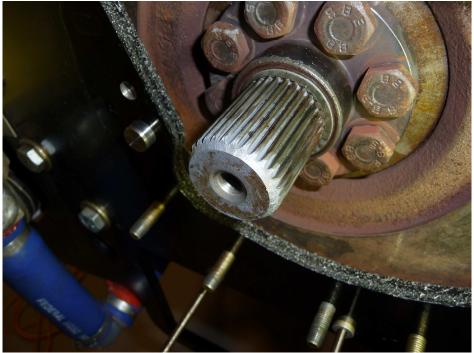
Photo 2

When I looked at the spline shaft still in the flywheel adapter, the male shaft also appeared to still be coated with the Moly 60, though not as much as I expected to see (Photo 2). If you look at the edges of the hole in the engine mounting plate you will see where all the Moly 60 went! That doesn't seem very good....

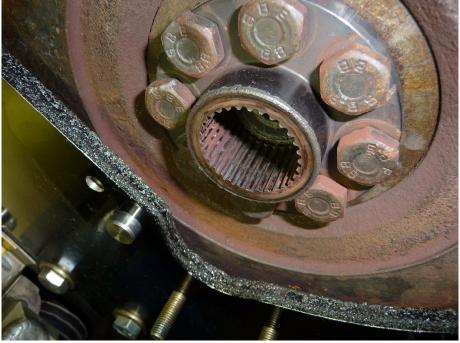
The next step was to remove the spline shaft and clean and inspect it. When I removed it from the flywheel adapter I was surprised to find most of the adapter to be dry with some iron oxide dust apparent, along with a very minor amount of Moly 60 residue (Photo 3). Notice the "ring" of Moly 60 around the perimeter of the flywheel adapter and all the Moly 60 around the edge of the adapter plate. This was NOT GOOD after only 25 hours of operation!

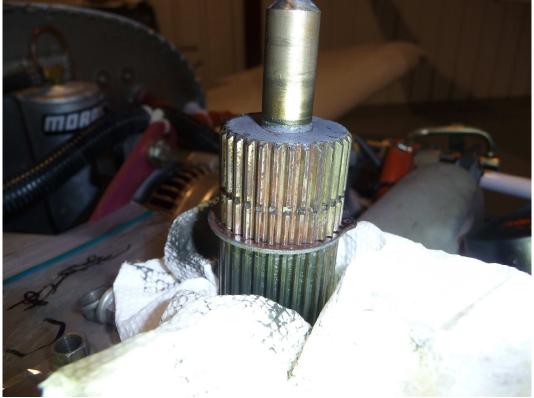
Here is a photo of the uncleaned spline shaft as removed from the flywheel adapter (Photo 4). You can see that the upper portion above the snap ring is quite dry compared to the lower portion. I decided that this needed to be fixed if I wasn't going to spend every third weekend lubricating the spline shaft.

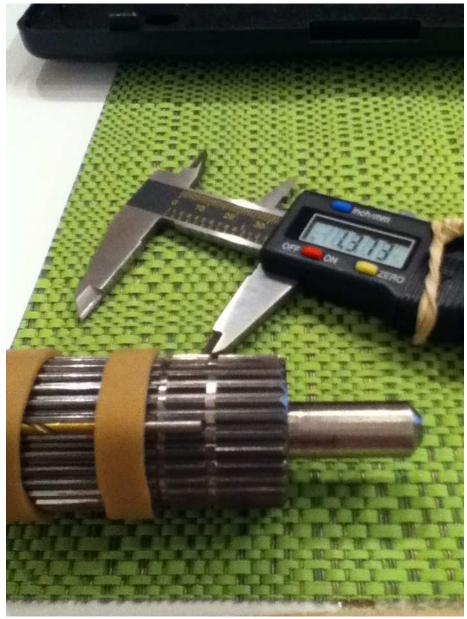
Photo 5

The next step I took was to clean up the male and female splines and measure the spline shaft for later reference. I had not done this in 2013 because I had no idea how to do it. In the interim I did some research and asked a machinist friend how to take measurements. The photo below (Photo 5) is how I accomplished this. I selected two brand new drill bits that measured the same diameter that fit between the teeth of the spline shaft but did not bottom out in the space between teeth. I measured the outside diameter including the drill bits placed 180 degrees apart. I recorded the measurements for a full 360 degrees or 30 measurements. I did this at each end of the shaft (first .025") and in approximately the middle.

As the face of the teeth wear, the pins (drill bits) will drop down into the space between the teeth and exaggerate the amount of wear so it can be measured more easily.

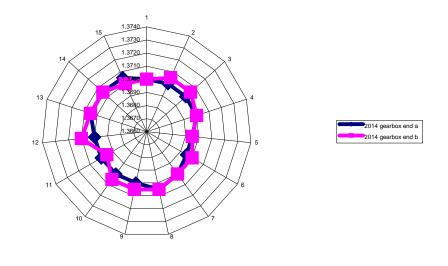
PSRU END OF SPLINE SHAFT

I entered the dimensions into an Excel spreadsheet and generated polar graphs for each column of numbers. As you can see from the numbers in the tables, and more easily from the graphs, I have tooth wear at the ends compared to the middle of the shaft. Each graph shows each number column as a different color to illustrate the limited resolution of the tools I am using and my own inconsistency taking measurements.

The outer ring of all three graphs is the same value (1.374) and the center of all three graphs is also the same value (1.366) so the graphs may be compared. Each increment outward from the center is 0.001 inches. Measuring using this technique appears to exaggerate the tooth wear by about a factor of four so I seem to have wear of about 0.0007 from the face of each tooth near each end.

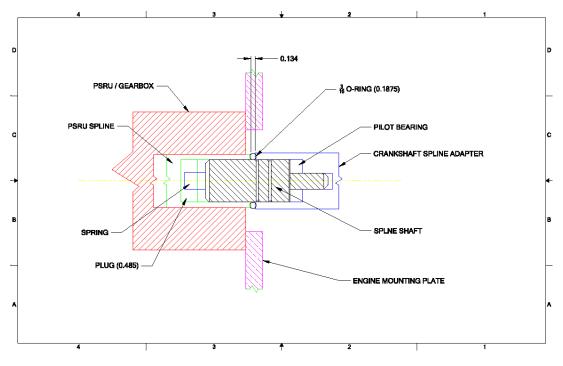
Drawing 1

To retain the Moly 60 a seal was needed. So I took measurements and sketched a cross section showing the mounting plate, flywheel adapter, spline shaft and PSRU input shaft relationships. After doing this it was very obvious why the Moly 60 was all over the edge of the hole in the mounting plate. I also found that I only have a space between the flywheel adapter and PSRU input shaft of about 0.134 inches, which a simple Viton O-ring should be able to fill. See the diagram below. (Drawing 1)

The installation of the O-ring required the removal of the existing snap ring on the spline shaft. So an alternate means of locating the spline shaft to keep both ends fully engaged was needed. A plug and spring arrangement was used to allow some movement (0.250 inches) but maintain engagement (Drawing 1).

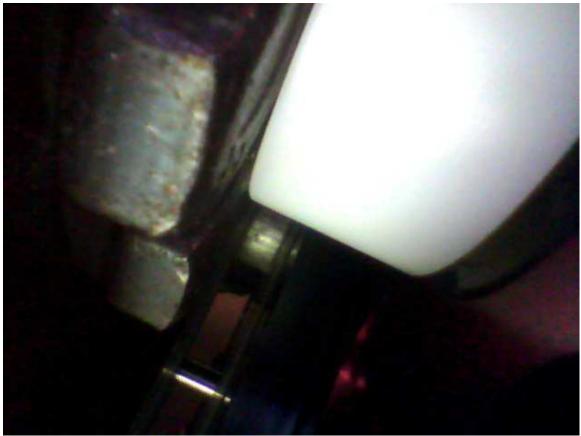
Photo 10

Finally, here is a photo taken by a low-resolution borescope showing the retainer and the space that exists between the retainer (white thing) and PSRU input shaft seal on the right (Photo 10). At the time the photo was taken we had almost 10 hours on the installation and there was no Moly 60 anywhere in sight.

If this comes to pass I plan to install a new spline shaft with no snap ring grooves to protect the O-Ring used as a seal from being chewed up by any longitudinal motion of the shaft.
