# National Transportation Safety Board

## **SPLINE WEAR MEASUREMENTS REPORT**

ERA14LA130

Vehicle: Victor M Cordero, RV-9A, S/N 90319, N19VC, Experimental Amateur Built

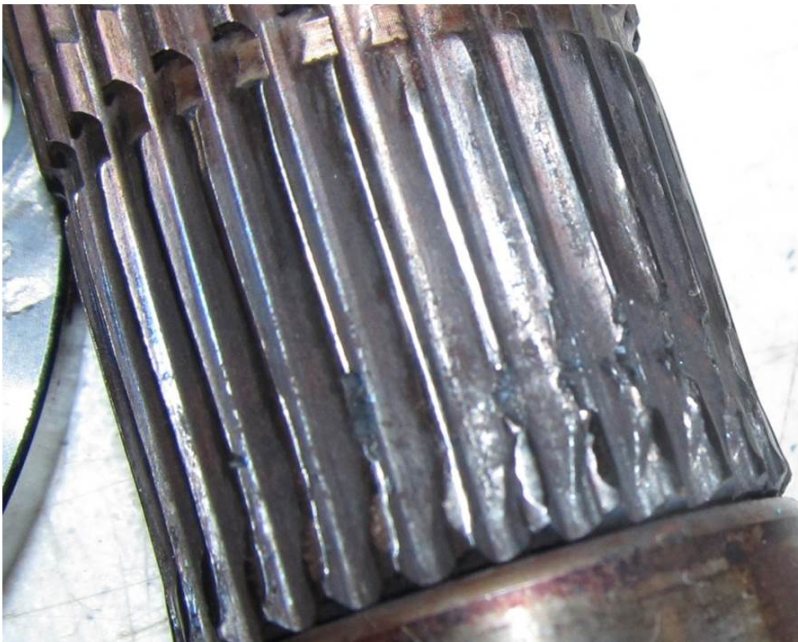
**Photo 2 – Engine end of the spline shaft - The thicknesses of the spline teeth on the engine end of the spline shaft were reduced by more than 75% due to wear. The remaining thinned-edges of the spline teeth were bent over due to rotation of the spline shaft within the drive disk adapter.**

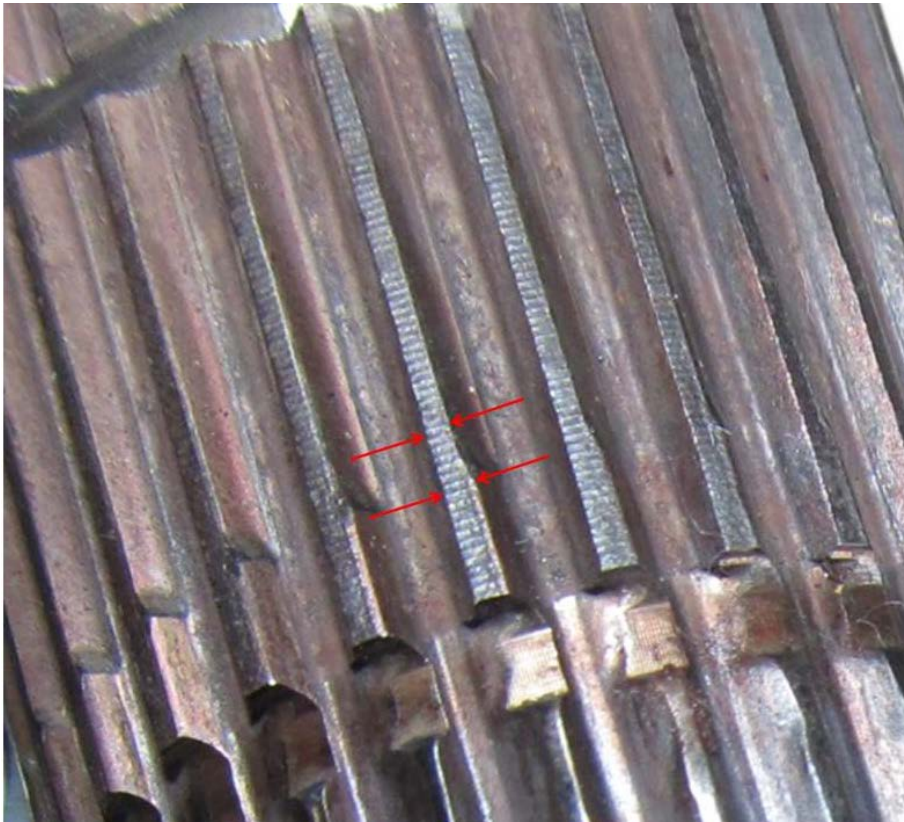
**Photo 3 – PSRU end of the spline shaft. The thicknesses of the spline teeth were reduced by more than 25% due to wear (arrows). The shape of the wear can be seen in the three teeth to the left.**

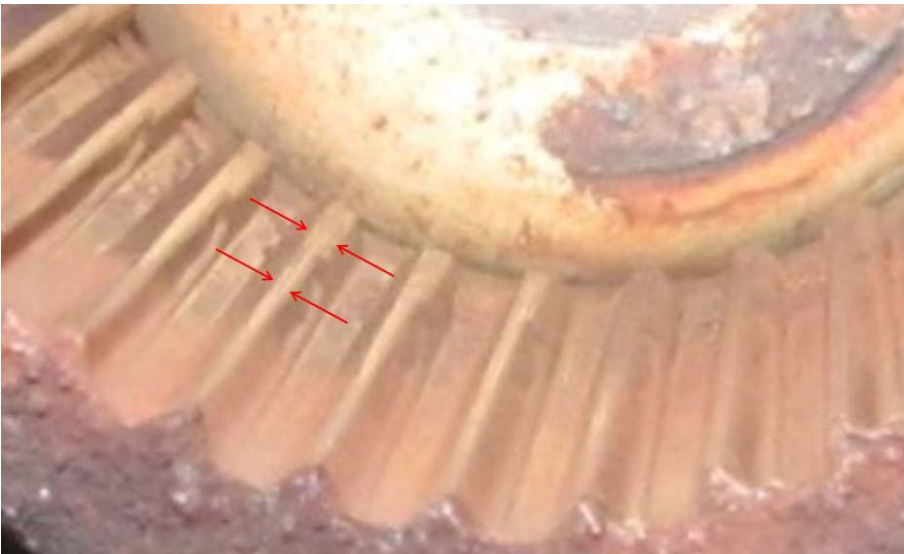
Further examination showed similar, but less severe wear at the PSRU end. The PSRU input spline grooves were worn such that the walls between grooves were 40% less than the original width. The spline teeth on the PSRU-end of the spline shaft were worn such that the thicknesses were more than 25% less than the original thickness. The spline shaft would wobble when inserted into the PSRU input spline. There was free play when the spline shaft was rotated while inserted into the input spline.

**Photo 4 – PSRU Input Spline – The thickness of the walls between the spline grooves on the input spline were reduced by more than 40% due to wear (arrows). The shape of the grooves can be seen in the five walls to the left.**
