## Title: Service Bulletin For 6 Cylinder SDS Equipped Engines

**Engines Affected:** H6 engines with SDS units NOT equipped with zener diodes.

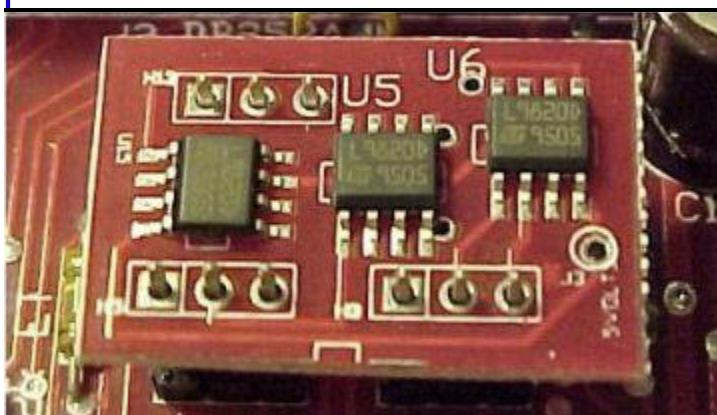
**Summary Statement:** Some SDS ECUs may have not have been sent back to Racetech Inc. for an upgrade to the coil driver circuits. This can result in one or two pairs of coils not firing on start up.

If your SDS board looks like the above then it will need 3 zener diodes added to it. Most

**Corrective Action:** All H6 owners should with SDS equipped ECUs should remove the lid from the ECU and look at the sub board shown in the photo. If your board does not have the 3 zener diodes (shown in right photo) soldered to the board, please return your ECU to us for the mod. We'll pay shipping both ways and do the mod at no charge. Send to:

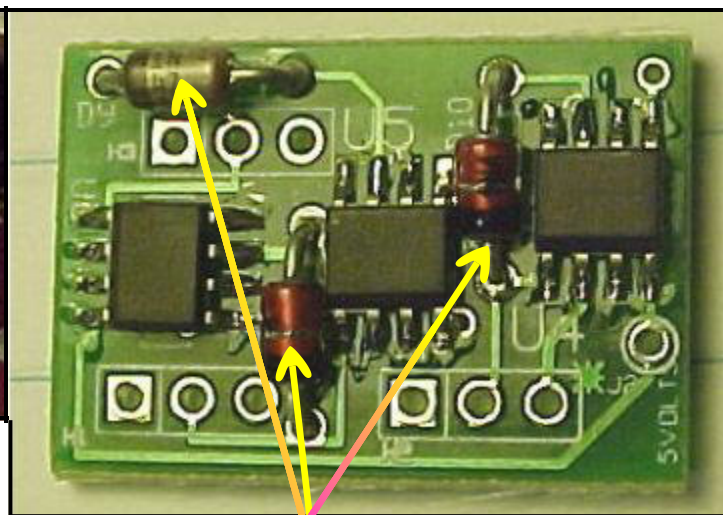
have been upgraded but everyone should check their SDS ECU. Zener diodes are shown on the upgraded board to the right so you know what they look like. It seems that perhaps inductive spikes from the engine starter motor may be damaging some of the driver chips.
