# National Transportation Safety Board

## GEAR BOX EXAM FACTUAL REPORT

ERA14LA130

Vehicle: Victor M Cordero, RV-9A, S/N 90319, N19VC, Experimental Amateur Built

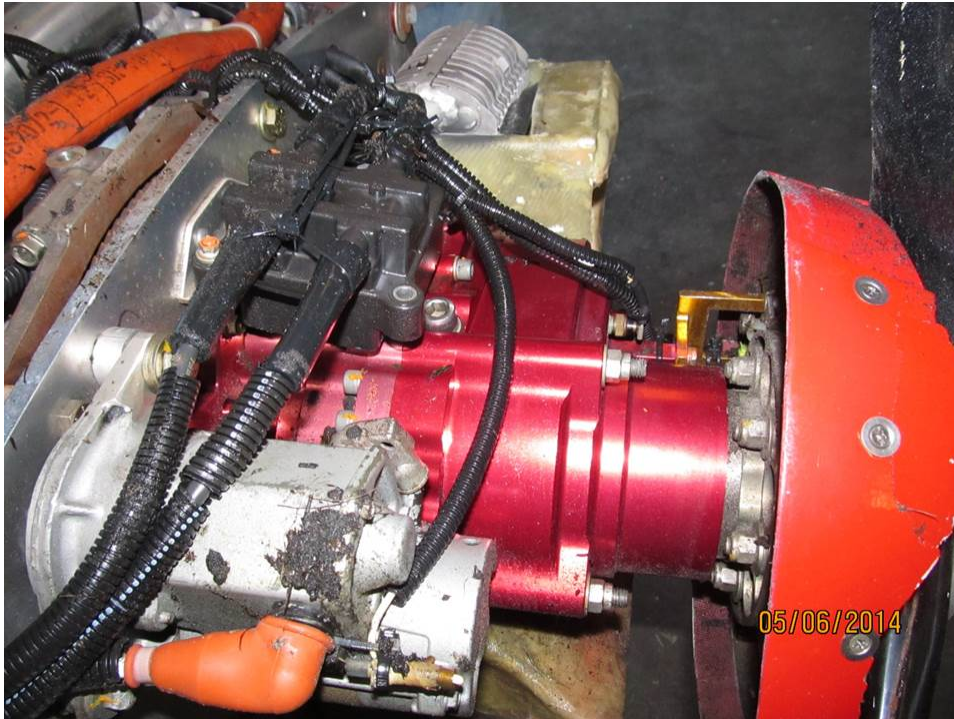
Photo 1 – Overall view of Gen 3 Version 4 PSRU.

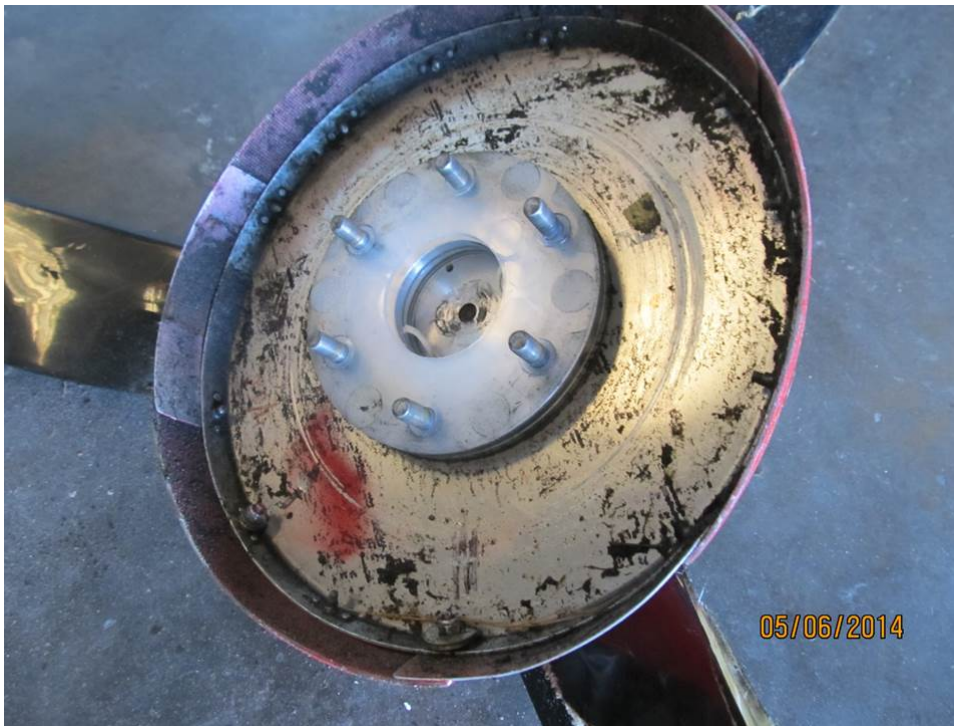
Photo 2 – Propeller hub.

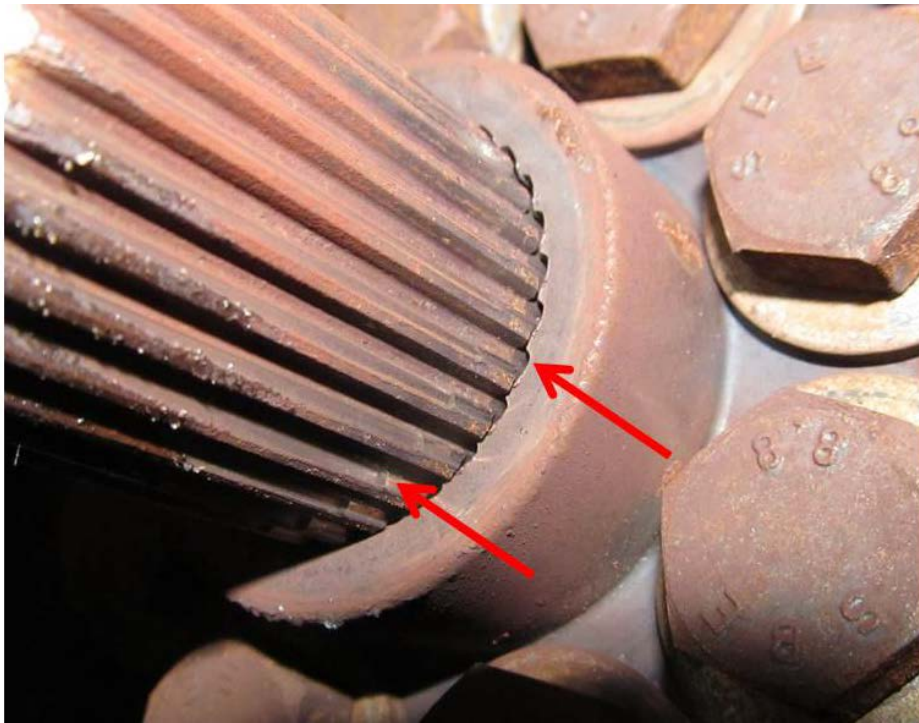
The grooves in the drive disk adapter were worn such that the wall between grooves was thinned by more than 75%, forming sharp cusps that had been bent over consistent with rotation of the spline shaft within the drive disk adapter. Wear surface features on the groove surfaces of drive disk adapter were consistent with fretting wear that had progressed to adhesive wear.

Examination of the spline shaft teeth that mate with the PRSU input spline using a 5X to 50X stereo zoom microscope revealed the flanks of the spline shaft teeth were worn by more than 25%. Wear surface features on the spline shaft teeth were consistent with fretting wear that had progressed to adhesive wear.

**Photo 4 – There is more than 25% wear of the teeth on the PSRU end of the spline (left arrow). There is more than 75% wear of the walls on the drive disk adapter (right arrow).**

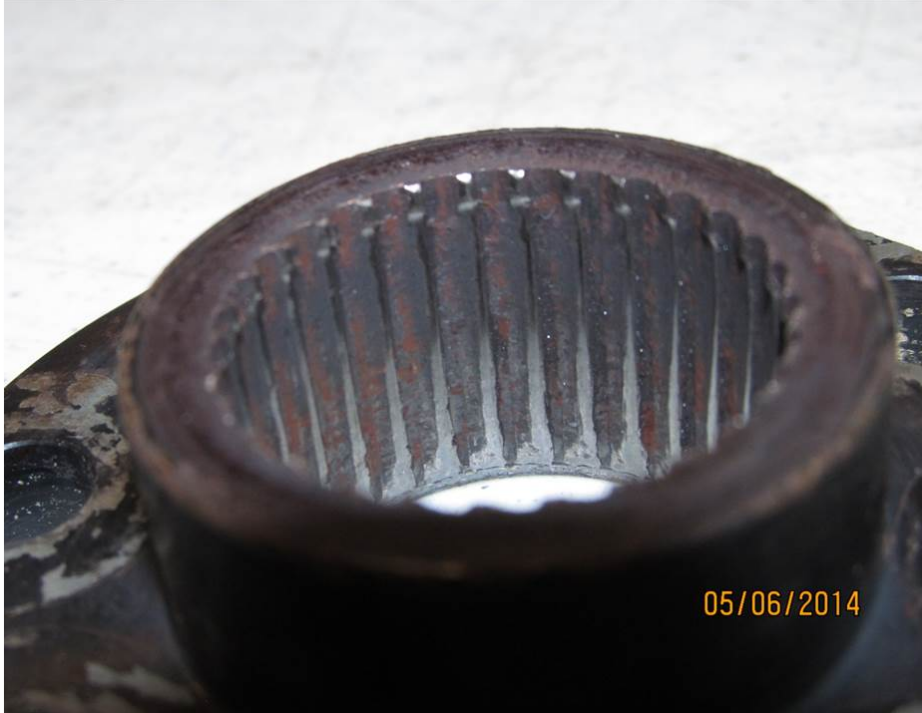
**Photo 7 - Severe wear of the groove walls on the drive disk adapter.**

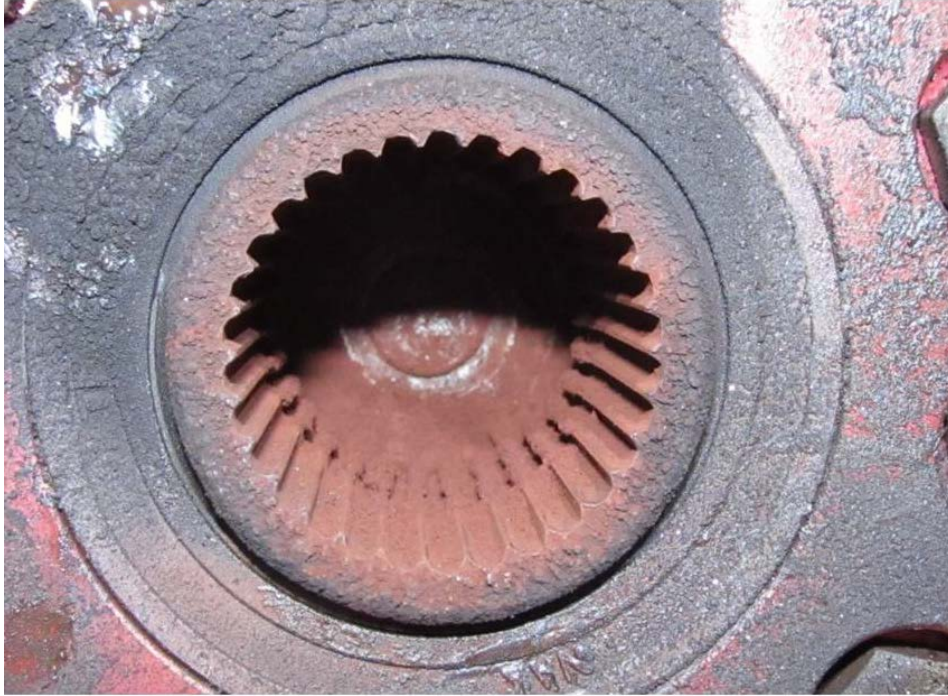
**Photo 9 - The PSRU input spline is worn to the point that the walls are pointed.**

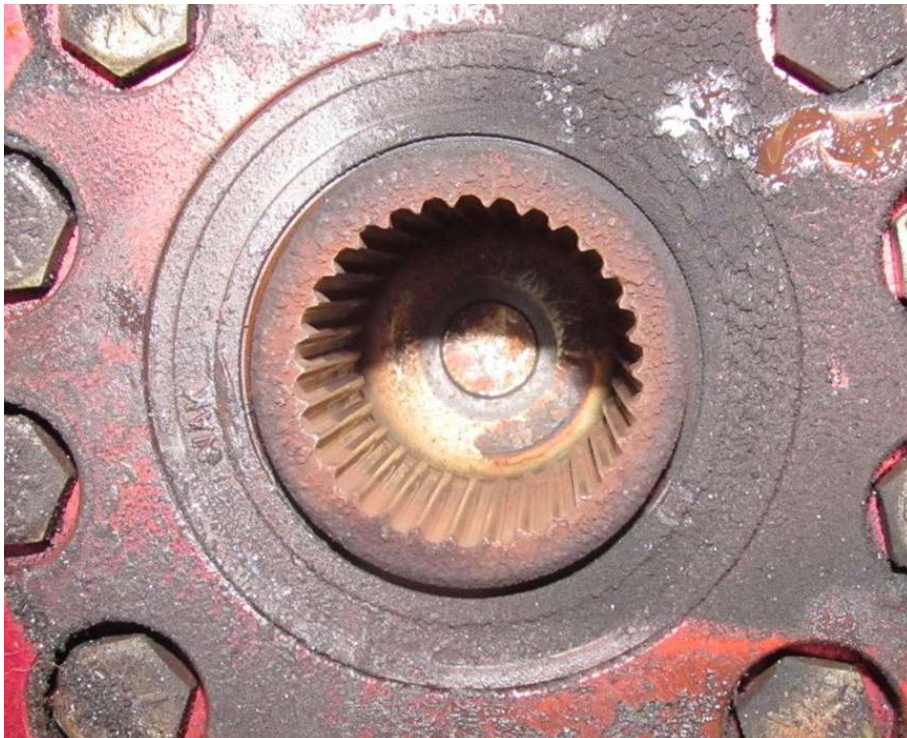
**Photo 10 – The PSRU input spline with dust removed.**

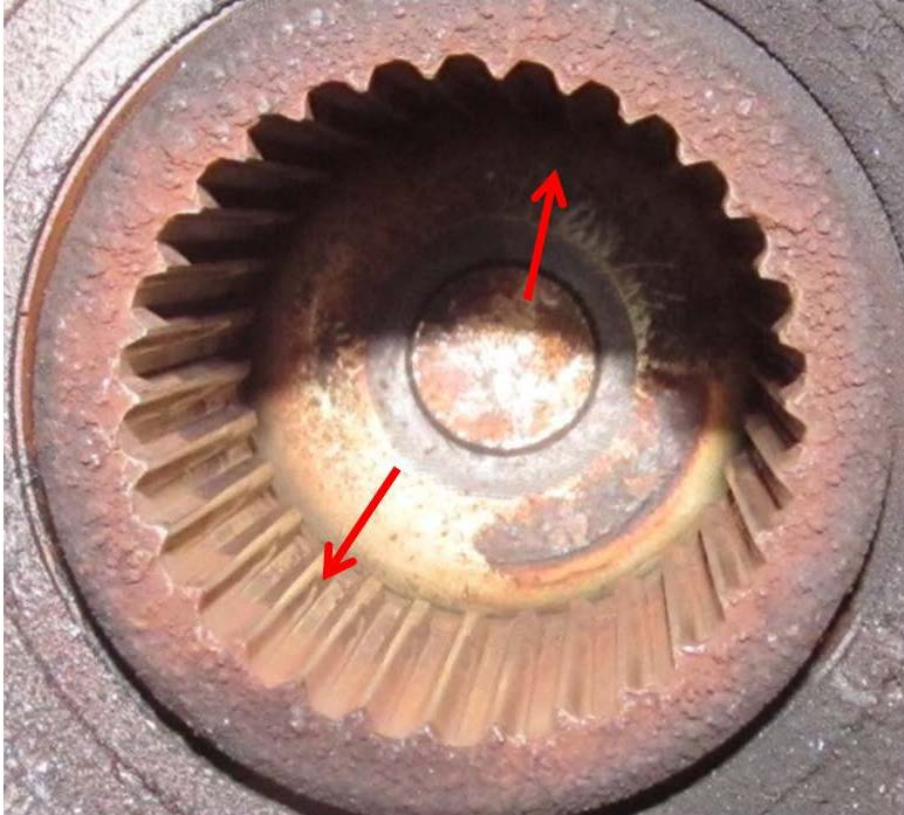
**Photo 11 – The upper arrow generally points to the many worn spline walls. The lower arrow points to the wear in the groove walls. The wear at the groove was more than 25%. Each spline had similar wear.**

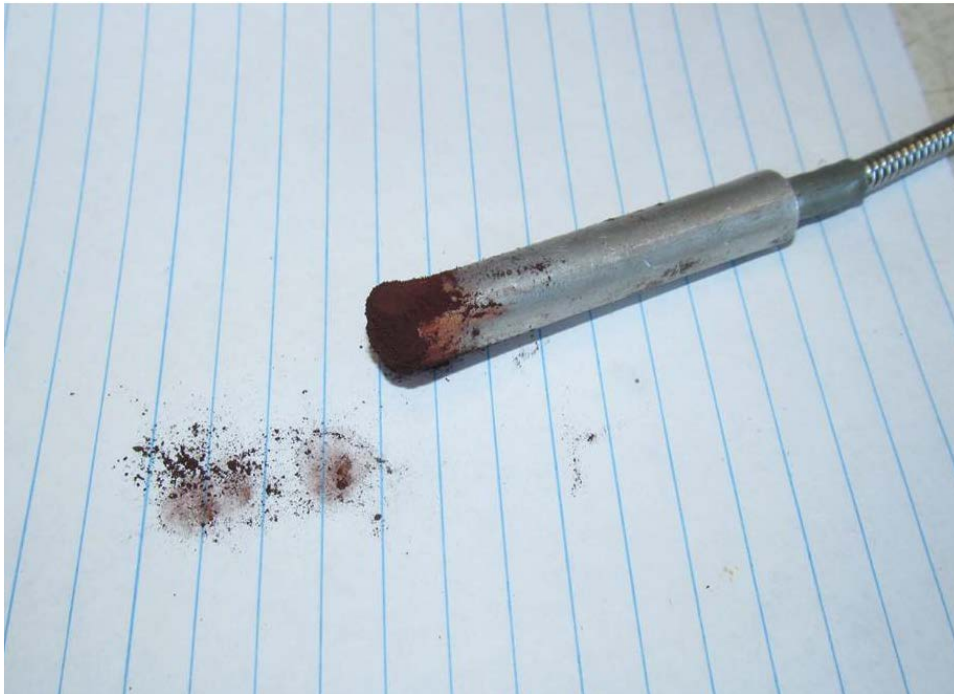
**Photo 12 – Red dust collected with a magnet.**

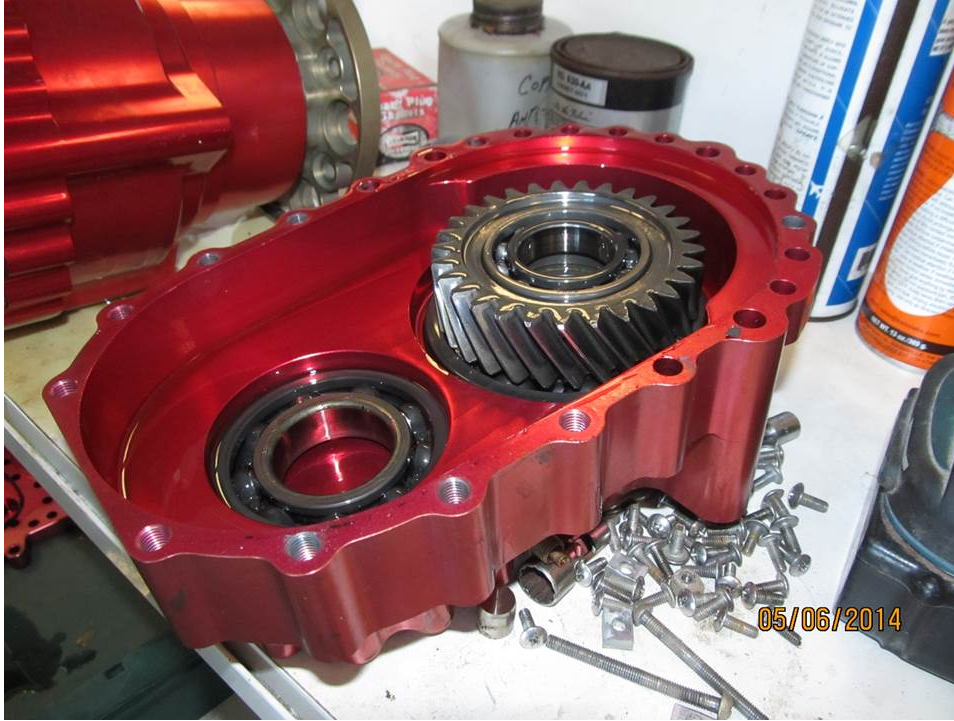
**Photo 13 – PSRU opened. The oil in the case appeared clear. There was no sediment inside the case.**

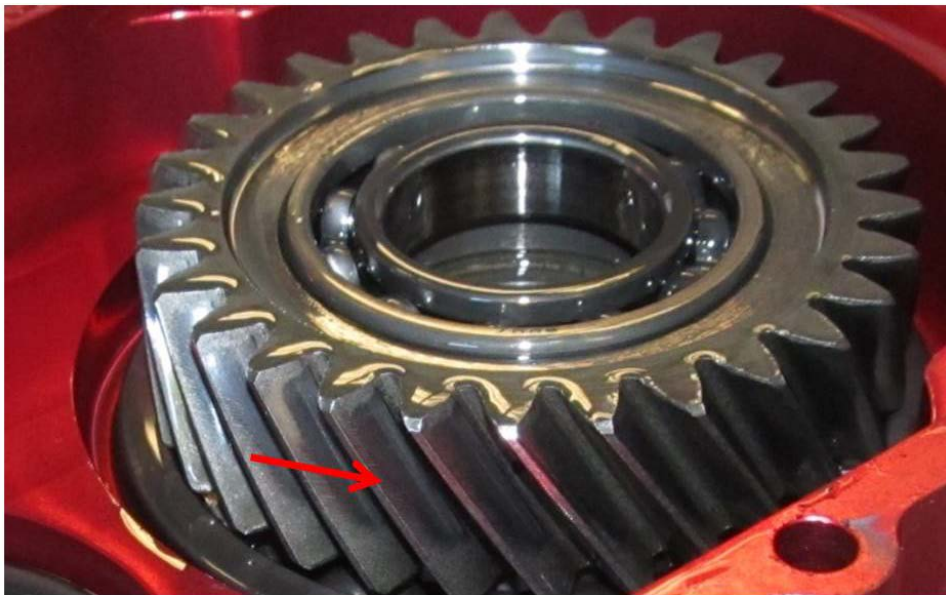
**Photo 14 – Arrow shows polished area of wear.**

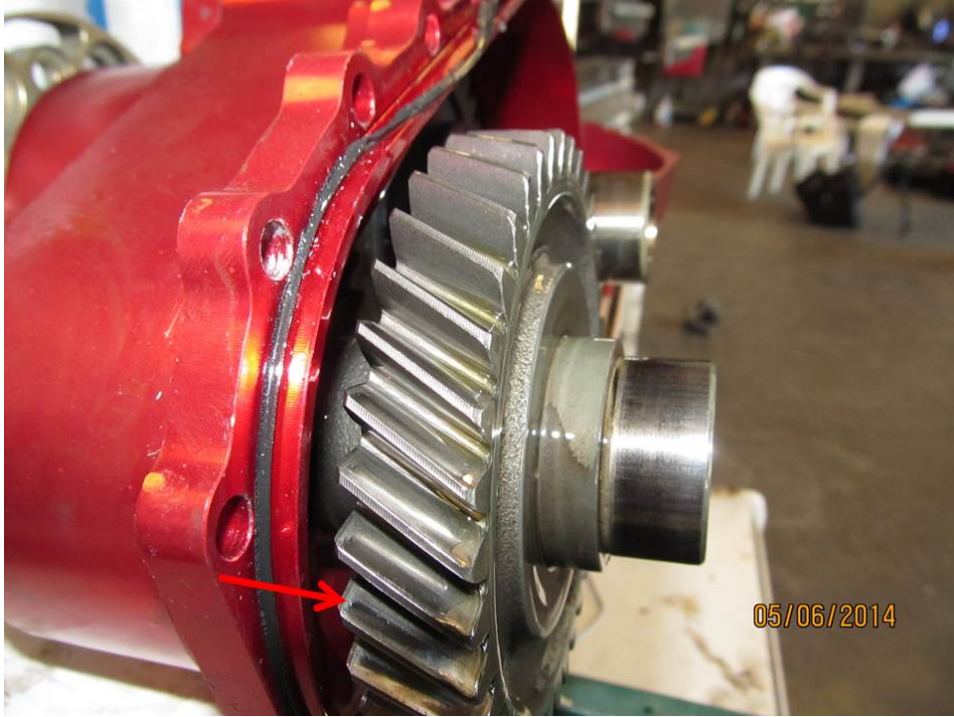
**Photo 15 - Arrow shows polished area of wear.**

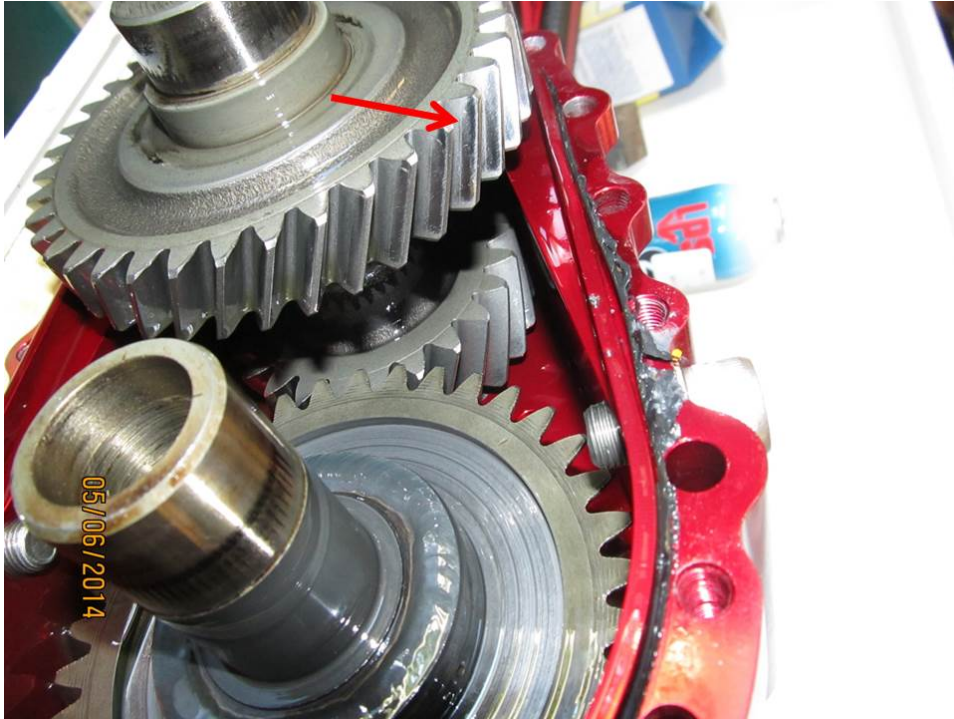
**Photo 16 - Arrow shows polished area of wear.**

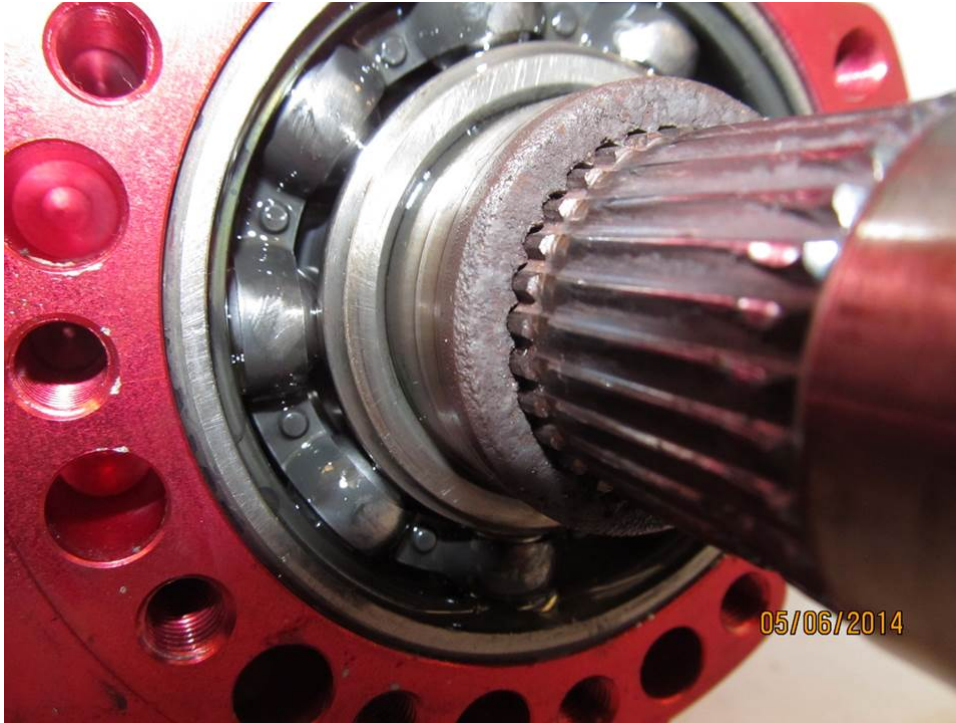
**Photo 17 – The spline shaft is pushed to the left, closing the gap between the PSRU input spline and the spline shaft.**

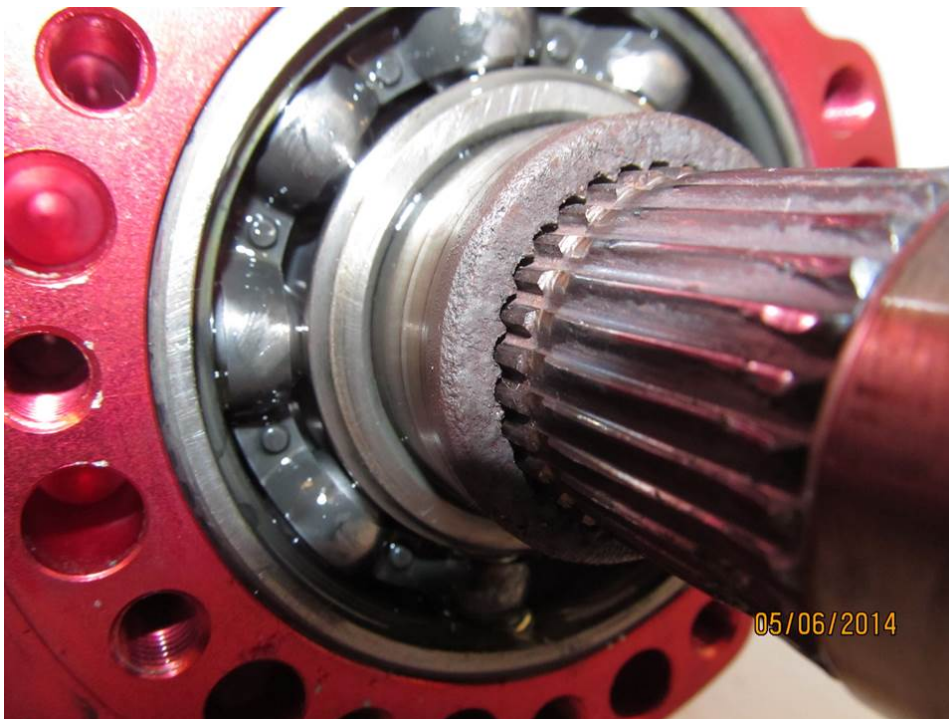
**Photo 18- The spline shaft is pushed to the right, opening the gap between the PSRU input spline and the spline shaft.**

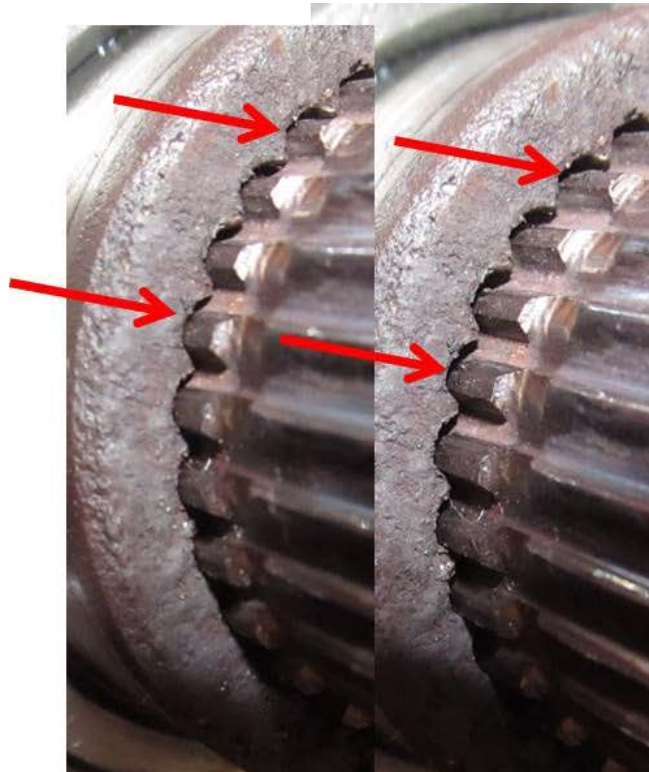
**Photo 19 – The left arrows point to the closed gap, the right arrows point to the open gap.**
