Title: Defective seal on H6 cam chain covers due to paint contamination.

Engines Affected: H6 engines with painted cam chain covers

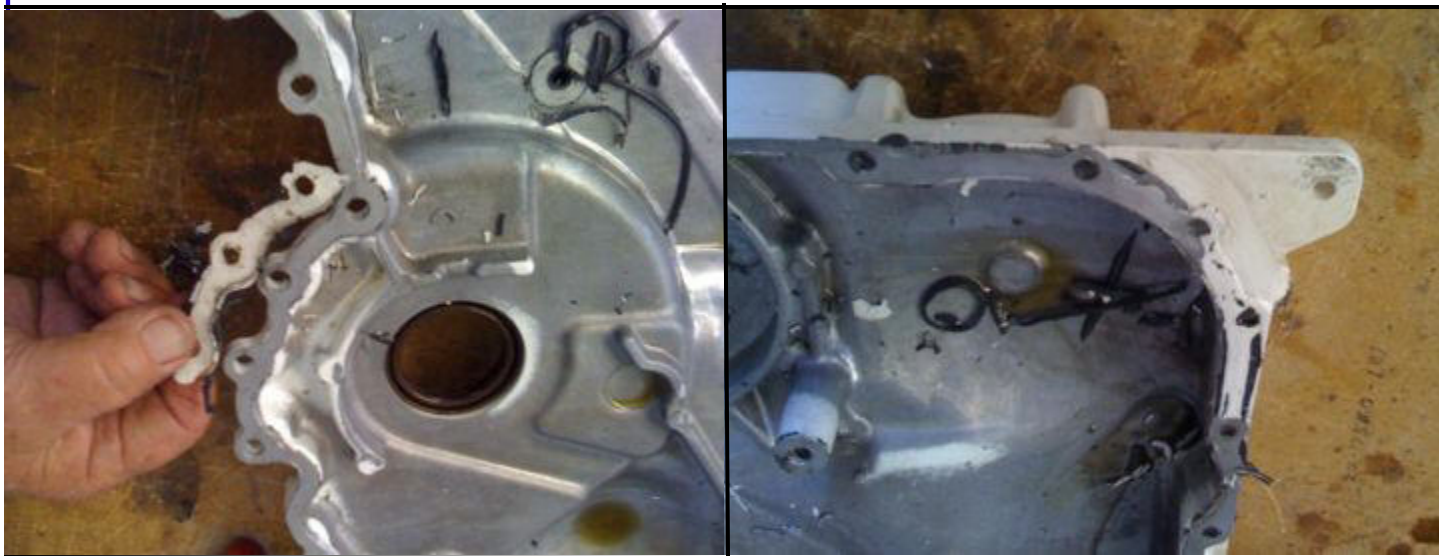
Discussion: The rear engine cover (cam chain cover) was removed and painted by the Egg factory as part of the engine beautification. The paint that was applied was sprayed onto the sealing surface that mates to the engine case. There is also overspray on the inside of the cover inside the engine oil area. The painted sealing surface caused the cover to not be sealed properly with the engine case resulting in a gross engine oil leak across the entire bottom of the cam chain cover. The problem did not become readily apparent until the engine had been started and warmed up a few times.

Corrective Action: If paint contamination is suspected the cam chain cover needs to be removed from the engine. All paint and old sealer needs to be removed from the sealing surface of both the cover and the engine case. Overspray should be removed from the inside of the cover. The cover should then be reinstalled using an appropriate sealer such as Permatex #85144 which is sold at auto parts stores under the name "the Right Stuff".

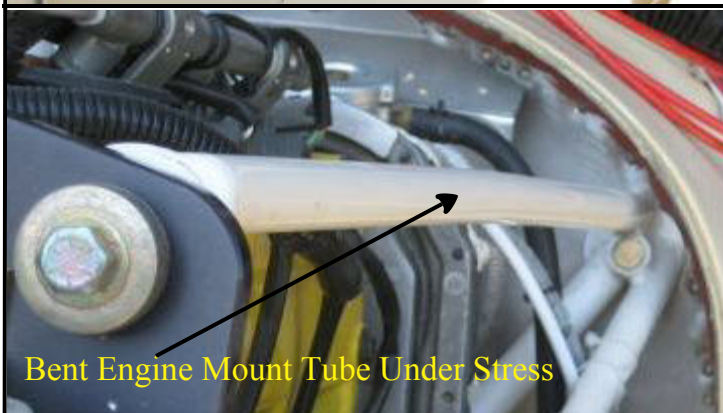
Bent Engine Mount Tube Under Stress
